A New Face on an Old Problem

By O. P. Williams,
 First Hydro Co., Wales, UK

Stwlan Dam is the 34-metre-high buttress dam standing amongst the peaks of Snowdonia near Blaenau Ffestiniog in the slate-quarrying heart of North Wales and, once upon a time, the world. Stwlan [pronounced “stoolán”] impounds 2.2 million cubic metres of water, all for hydro-electric generation of a special kind: pumped-storage. Water from Stwlan falls 300 metres through shafts and tunnels to four 90-megawatt hydro-turbines in Ffestiniog power station, generating up to 360 megawatts within minutes of switch-on. This energy is crucial in helping the UK electricity grid system meet its rapid fluctuations in demand hour by hour, even minute by minute. The reservoir is refilled by pumping water back up the tunnels and shafts on cheaper electricity at times of lower demand, generally overnight.

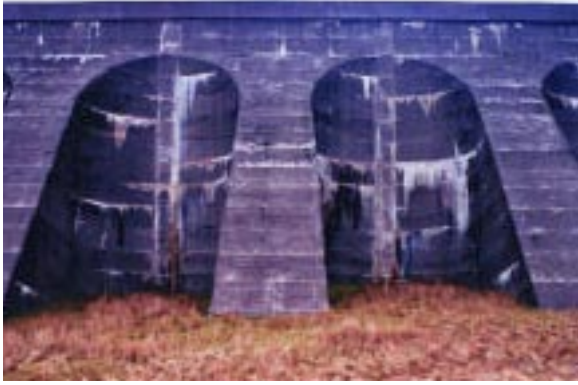
Left: Efflorescence and subsequent spalling on the Stwlan Dam
 Below: General view of the dam
 Photos courtesy of the author

Like many mass concrete structures of its age, Stwlan’s downstream face became streaked with efflorescence soon after completion. What became called the “stale-bread” effect was due to a combination of too much cement content and overly slow rates of construction. This combination created high differential temperatures during early curing, which resulted in slightly un-bonded lift lines. Water seepage through the dam walls reacted with free lime and slowly sealed almost all the leakage.

Stwlan also had an unusual double-wedge contraction joint between its buttresses. These joints were generally never quite sealed, and seepage continued, freezing and thawing winter after winter, until eventually, fragments of concrete began to spall and fall off. The ground between the buttresses had then to be fenced off to protect the public and grazing animals from falling concrete.

Sealing the more accessible downstream face of the dam was rejected; water would continue to enter the structure, and repairs were likely to fail under the high and cyclical water pressure coming from the reservoir. So the less accessible upstream face would be sealed.

re-flooding more than 250 times, it was clear that, for adhesion, uniformity, residual thickness, crack and defect bridging, and edge integrity, only one product was virtually blemish-free: a 100% solids epoxy incorporating Kevlar® (aramid fibers). Moreover, wind, rain, temperature changes, and humidity problems during application

and early curing did not adversely affect the epoxy. In conjunction with no waste and no visual contamination of the lake water on first submergence, First Hydro considered the epoxy to clearly be the best performer. Despite its higher unit cost, it was also evaluated to be the best over all value. Accordingly, the product was specified for all the remaining joints on the dam.

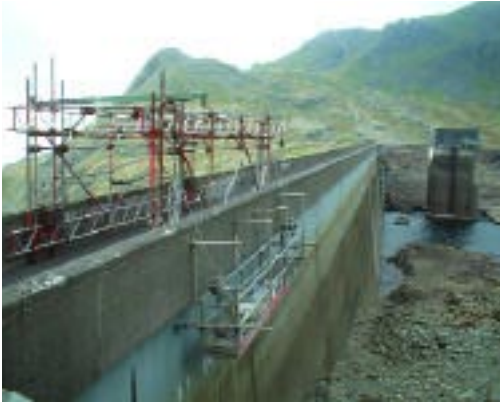
Access platform suspended from special mobile rig on the dam crest for second round of coating trials

contractor, formerly Palmers but now Pyeroy of Rosyth and Newcastle, then applied the three best coatings from an access platform suspended from a special mobile rig on the dam crest road.

Each product was applied in a 4-metre-wide strip the full height of a double buttress joint, each under the direction and supervision of the coating manufacturer.
